Date: April 26th

SUBJECT: AcuraWatch™ 360 Bumper Cover Repairs

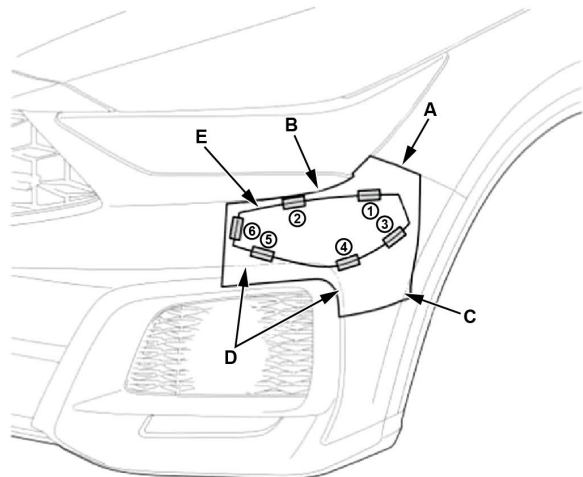
The radar waves passing through the bumper covers are more affected by the type and location of the repair. Cracks or dents within the radar wave emission range cannot be repaired and will require bumper replacement.

To assist technicians in determining where the radar wave emission area is, a printable template is provided in the body repair manual. This template can be taped onto the bumper and will help determine if the bumper can be repaired or will require replacement.

- Template for Non-Repairable Zone on Bumper Cover [Blind Spot Information System]
- Precautions for Handling Bumpers [Blind Spot Information System] Page
